STREAM RESTORATION

Using Bioengineering Techniques

“A Demonstration Project”

Rock Creek Park, City of Frederick

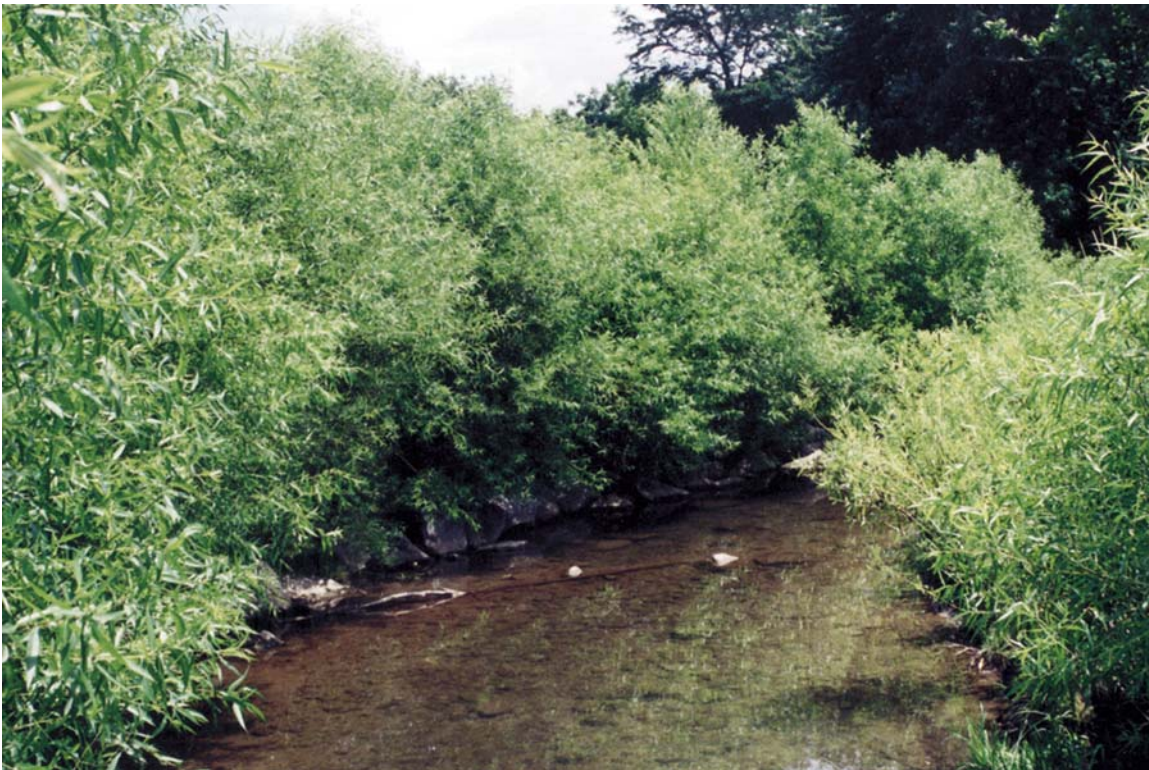
Baughman's Lane, 2 years after construction

Streamside woody vegetation increases habitat diversity and filters runoff.

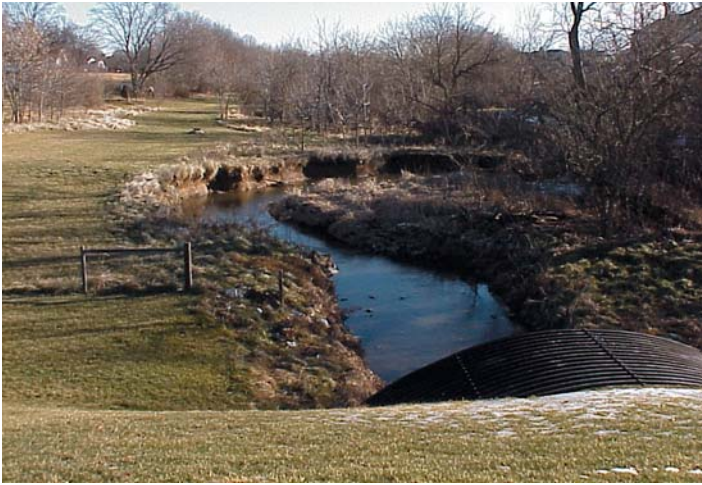
Before
Eroding Stream Meander

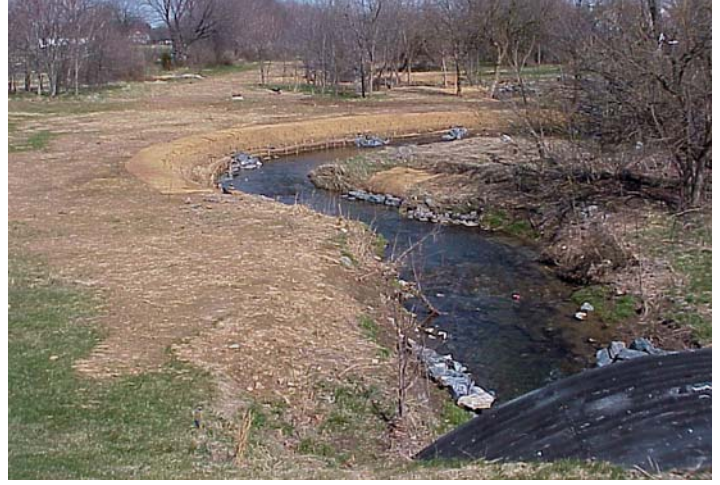
After
Protected Stream Meander

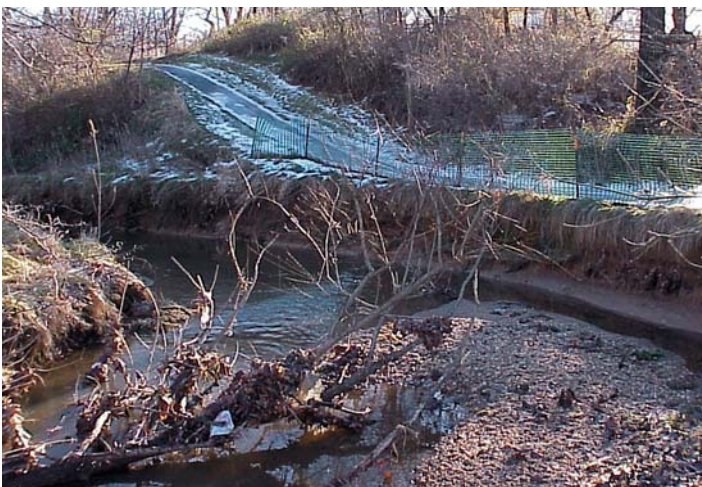
Before
Eroding Bike Path

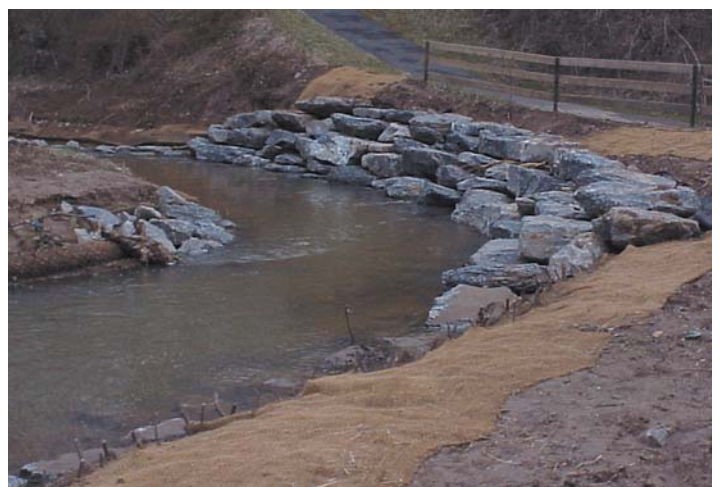
After
Protected Bike Path

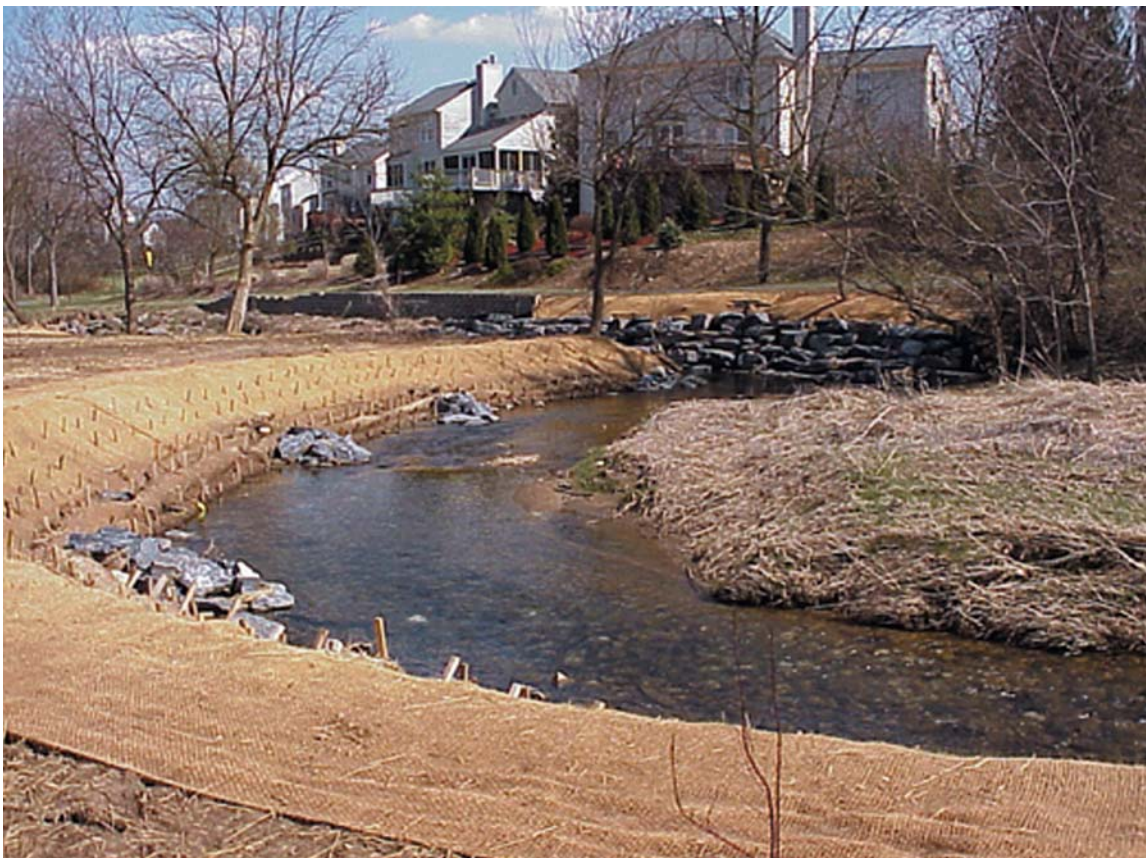
Stabilized streambanks using coir fiber matting, coir fiber roll toe protection and rock vanes

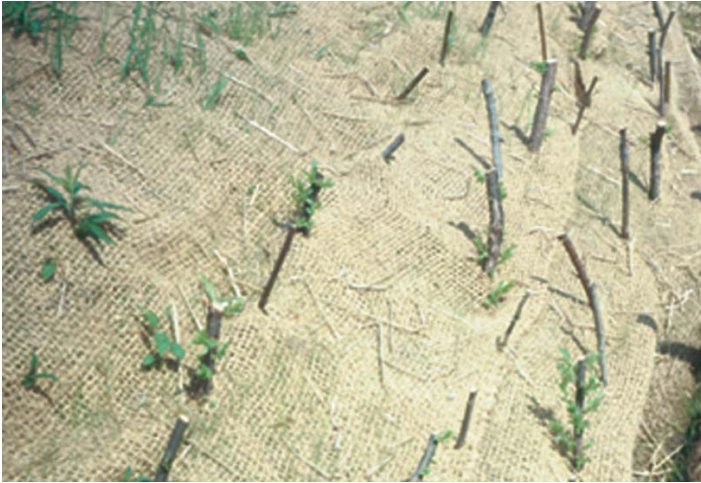
LIVE STAKES / COIR FIBER MATTING

Stout live woody cuttings create root mat that reinforces and binds soil after fiber matting biodegrades.

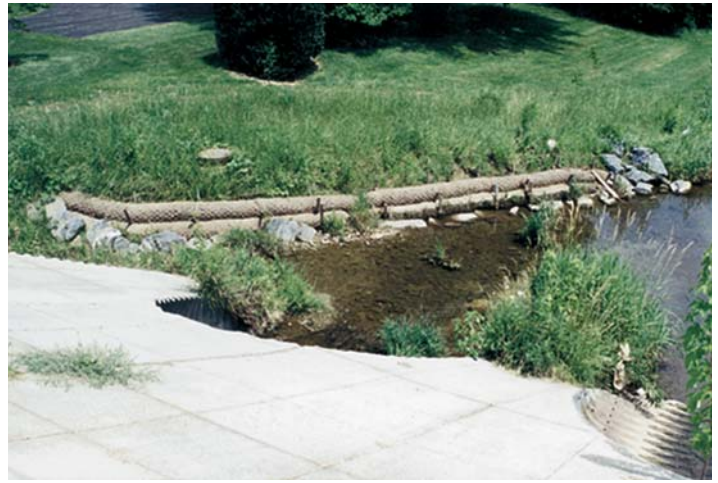
COIR FIBER ROLL

Fiber roll protecting toe of slope near sewer line and man-hole. Provides toe protection and enhances establishment of permanent vegetation.

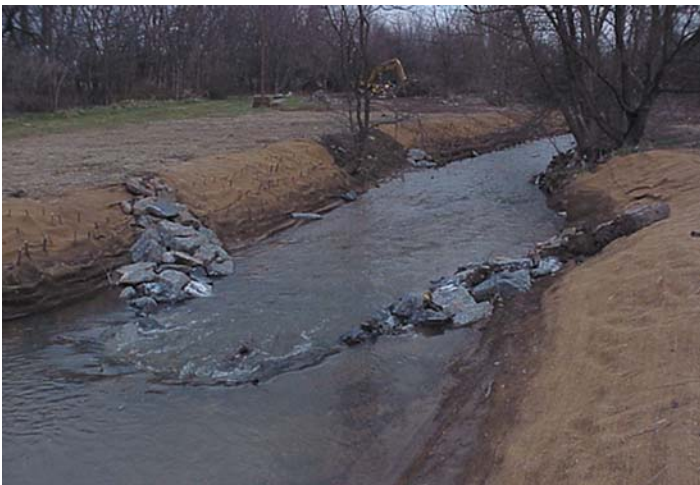
ROCK CROSS VANE

Directs flow to center of stream, away from banks, reducing erosive pressure. Increases variety and quality of fish habitat.

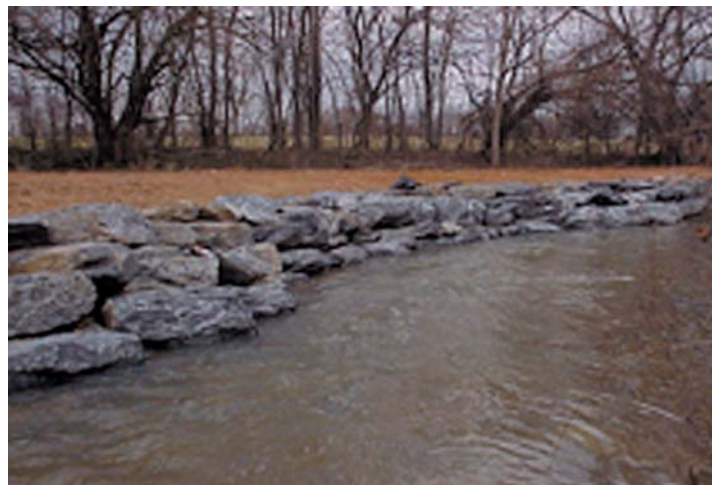
IMBRICATED ROCK

Allows trapping of sediment between rocks and establishment of natural riparian plant species.
